DEPARTMENT OF PUBLIC UTILITIES

PIPELINE ENGINEERING AND SAFETY DIVISION

INCIDENT REPORT

453 Worthington Street, Springfield, Massachusetts
November 23, 2012

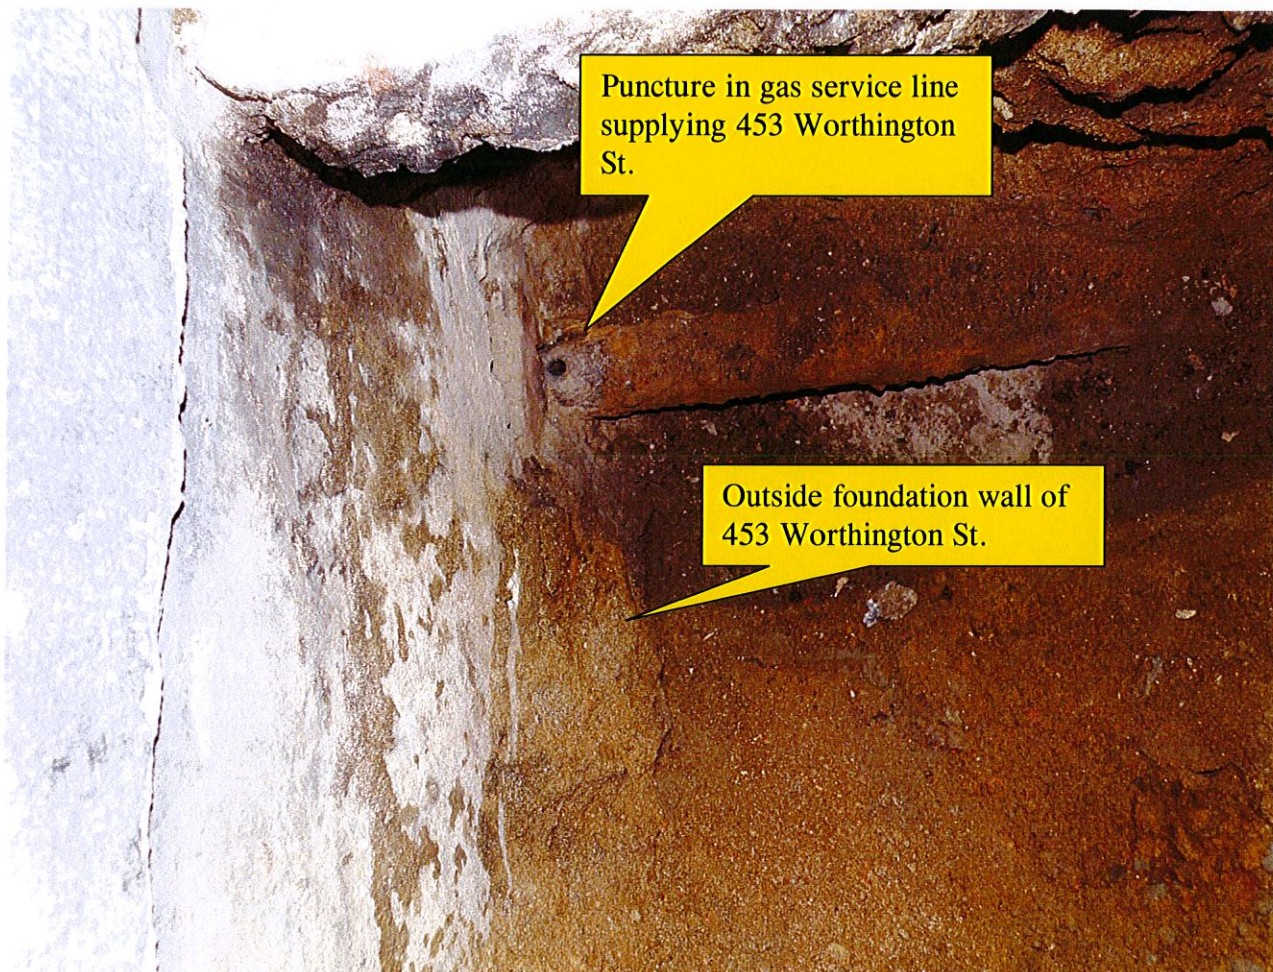
Exhibit 5(c) - The Damaged Gas Service Supplying 453 Washington Street In Situ

The source of the leak was determined to be an approximate half ($\frac{1}{2}$) inch puncture to the steel service casing which housed the one and a quarter ($1\frac{1}{4}$) inch plastic gas service pipe that was also punctured (Exh. 5(c),(d)). The circumference of the probe bar that the CMA technician used for the leak investigation was the same circumference as the half ($\frac{1}{2}$) inch hole in the casing and the plastic gas carrying pipe (Exhs. 1, 4, 5(d)).

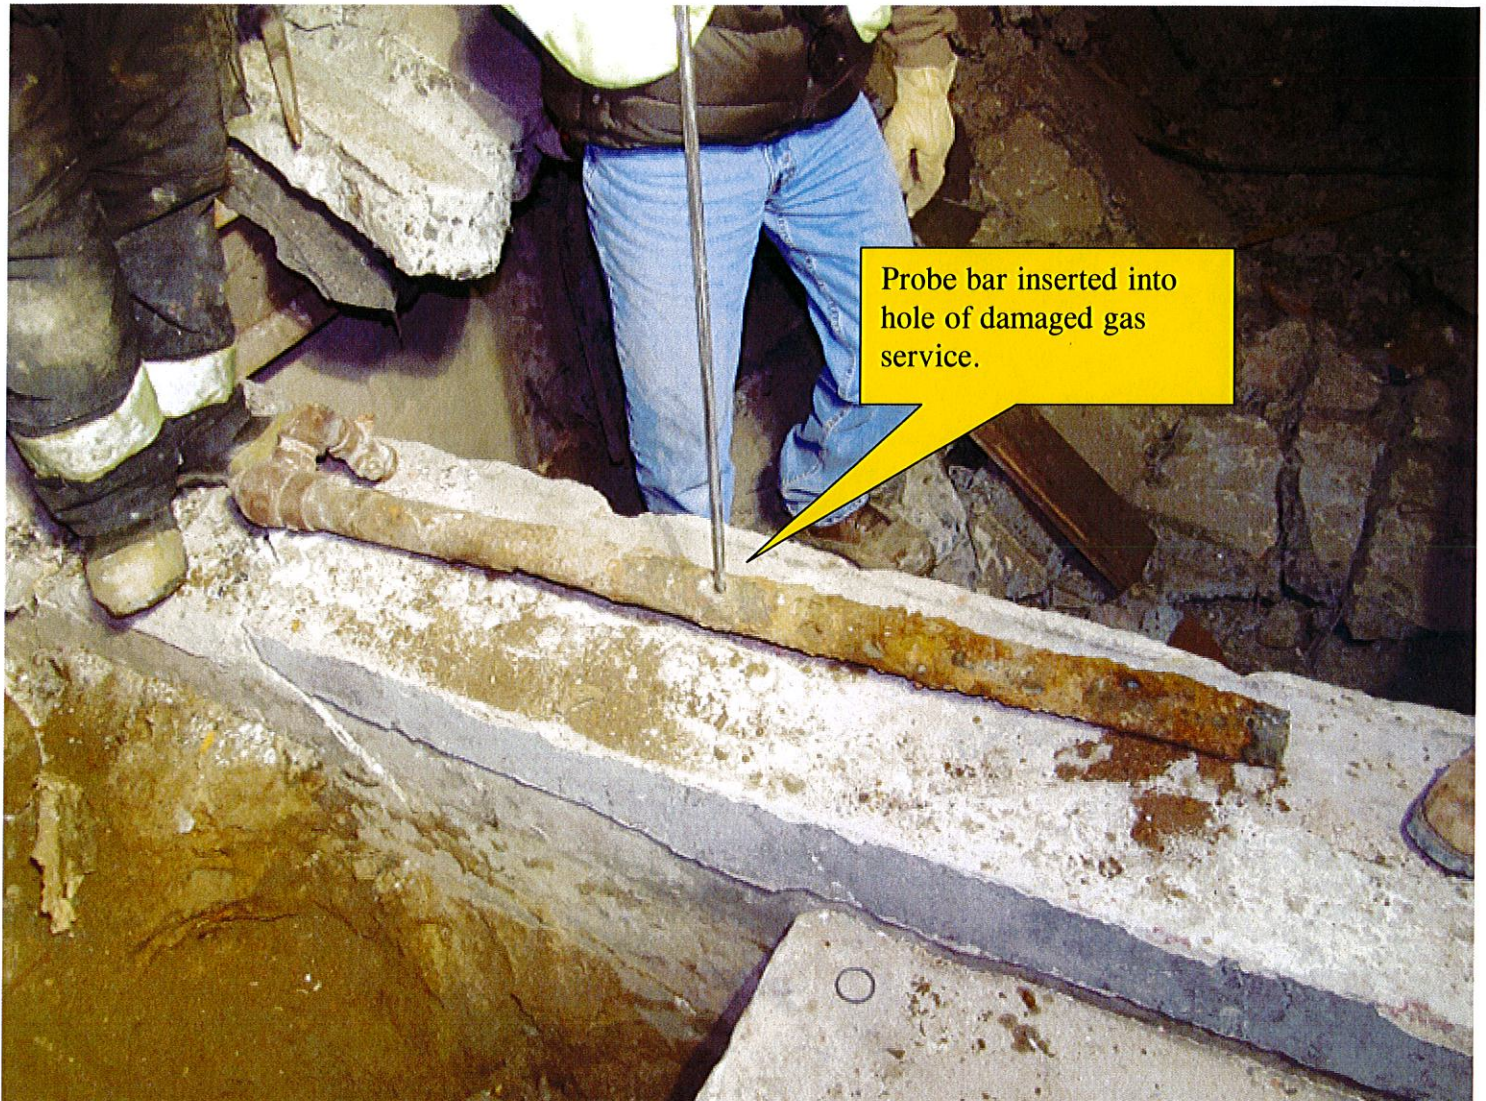
Exhibit 5(d) - The Damaged Gas Service With Probe Bar

- i. The CMA Technician punctured the gas service with his probe bar when he placed this barhole against the foundation wall. The Technician heard gas escaping immediately.

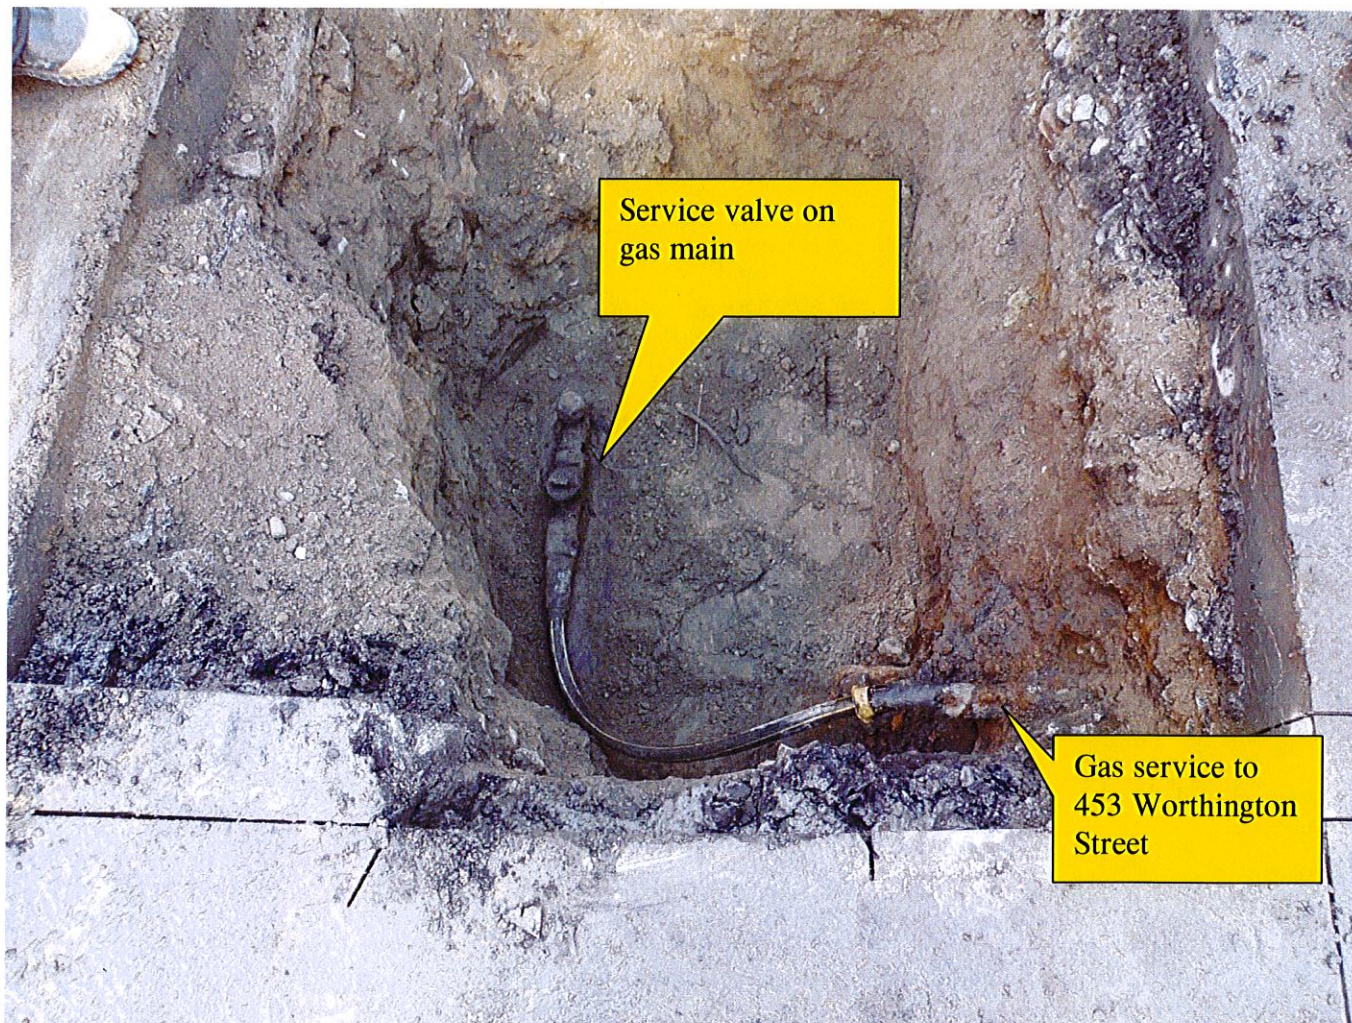
Exhibit 5(e) - Gas Service Connected to the Gas Main in Worthington Street

CMA first soap tested the short, approximately one (1) foot section of the gas service between the service tee and the service valve (Exh. 5(e)). The Department Investigators observed no indication of gas leakage at the service tee and service valve during the soap test.

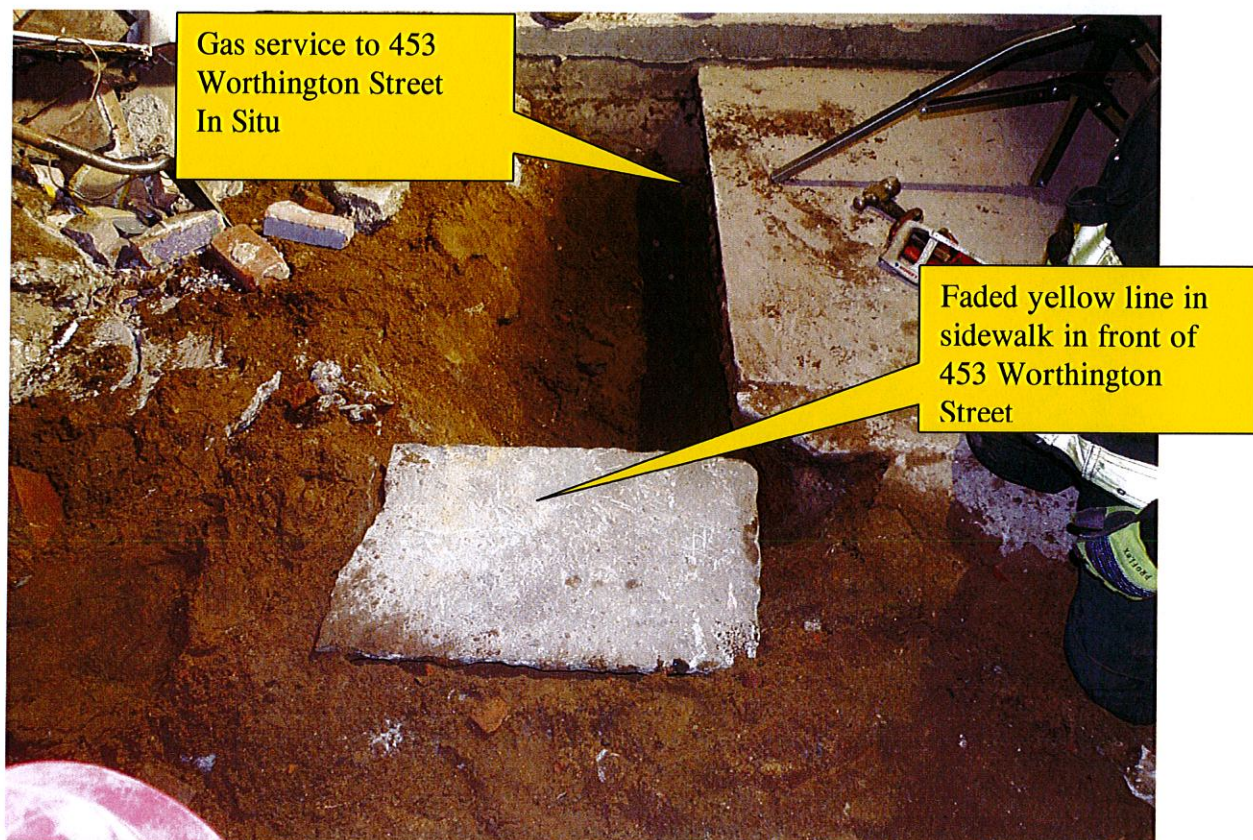
Exhibit 5(f) - The Faded Yellow Line In Relation to the Damaged Service Line In Situ

The puncture in the gas service was approximately twenty one (21) inches to the right side of the faded yellow mark found on the sidewalk (Exhs. 3(a),(b),(c), 5(f)). The yellow mark was in line with the gas service valve that was located in the street, approximately twenty eight (28) feet away (Exhs. 4, 5(e),(f)).

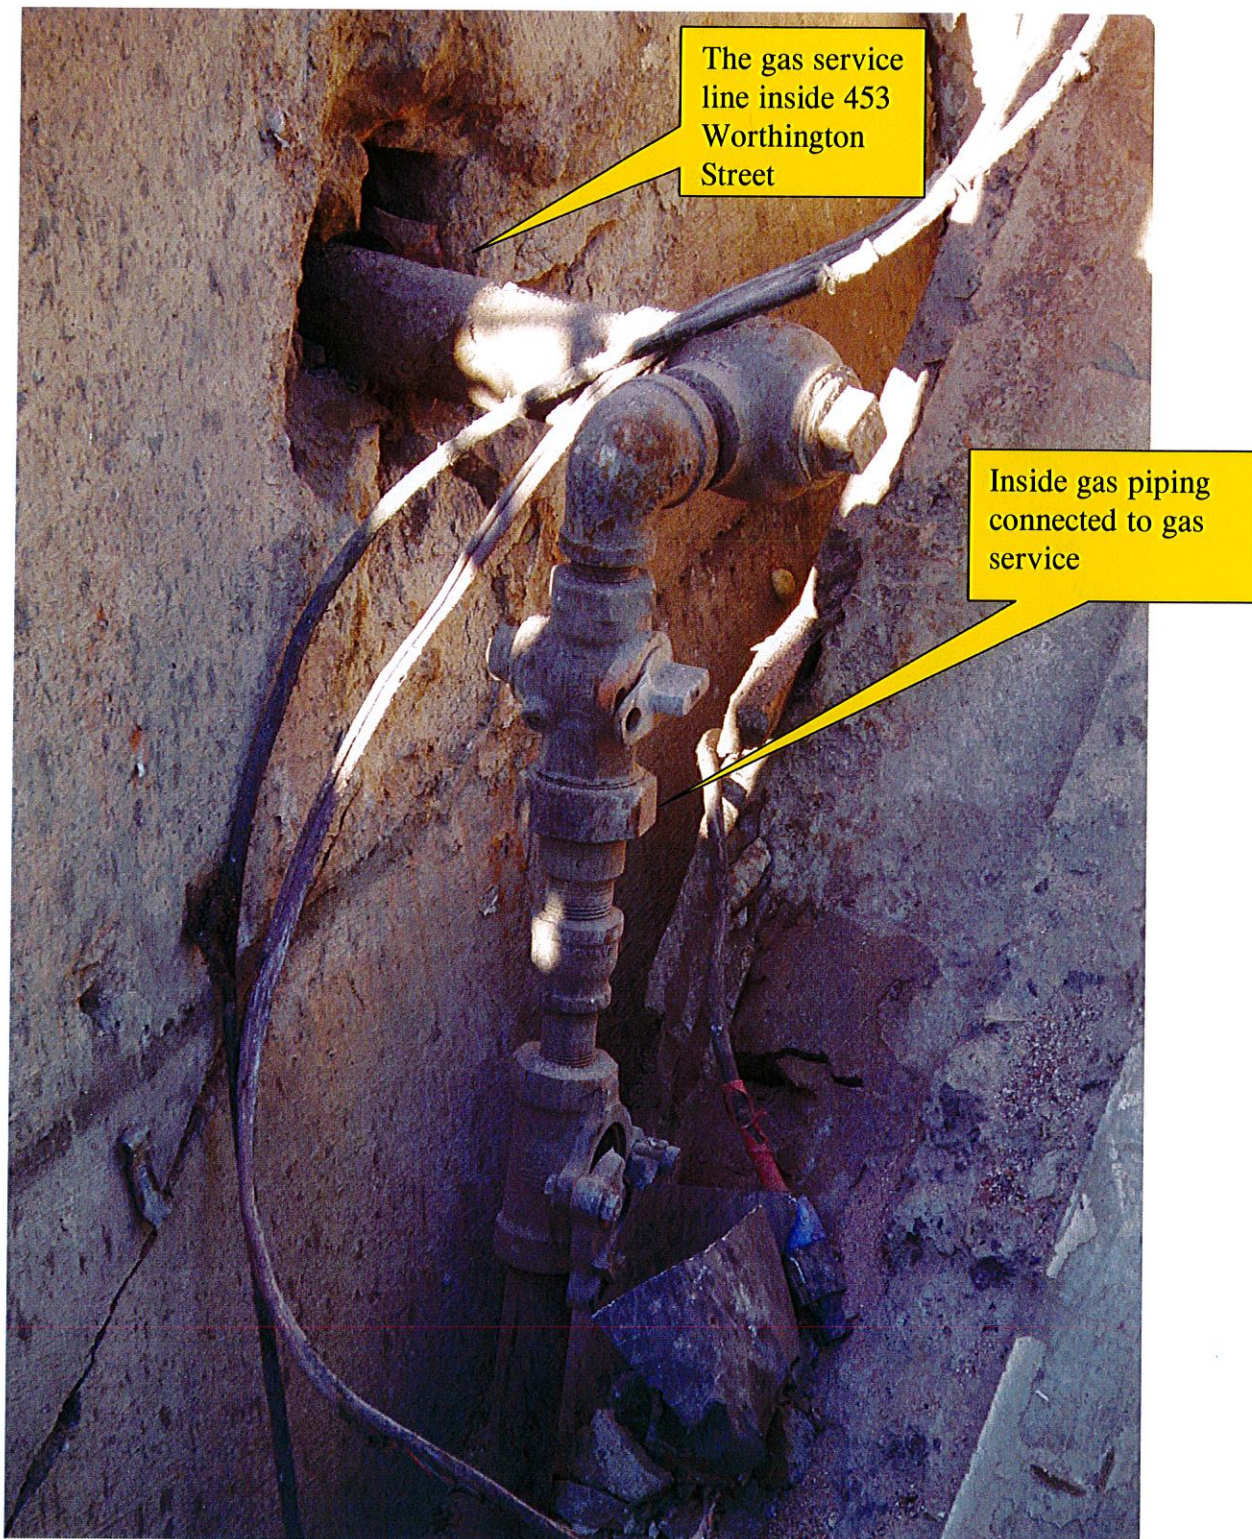
Exhibit 5(h) - Gas Service Piping Inside 453 Worthington Street

CMA records indicate that on June 27, 2008, and August 23, 2012, CMA conducted an inspection of the inside gas piping at 453 Worthington Street (Exh. 13). CMA detected no leaks and reported that the pipe was in good condition (Exh. 13).
